# INDOOR AIR QUALITY ASSESSMENT

## High School of Commerce 415 State Street Springfield, Massachusetts

Prepared by: Massachusetts Department of Public Health Bureau of Environmental Health Assessment May, 2002

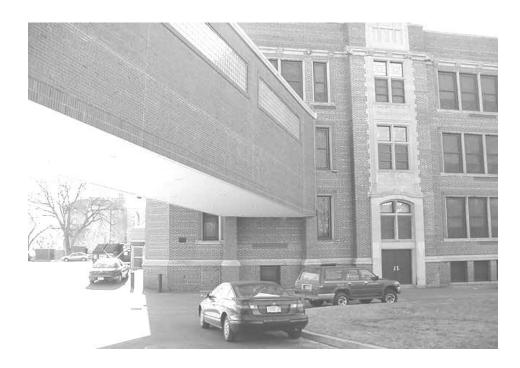
basement and subbasement levels. The 1998 building contains science classrooms, gymnasium, weight room, exercise room, locker rooms and a swimming pool. The two buildings are connected by an elevated sheltered walkway (see Picture 1). The sash windows are openable in both buildings.

**Elevated Walkway**

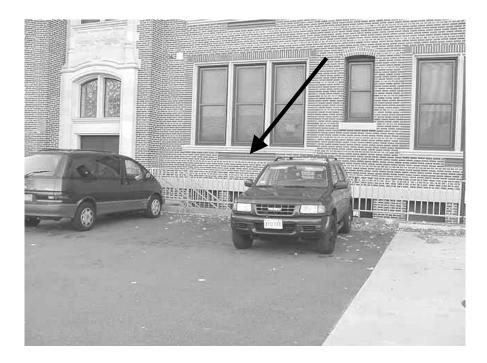
Fresh air in the 1915 building is supplied by a unit ventilator (univent) system in classrooms with windows. Univents draw air from outdoors through a fresh air intake located on the exterior walls of the building (see Picture 2) and return air through an air intake located at the base of each unit (see Figure 1). Fresh air and return air are mixed, filtered, heated and provided to classrooms through a fresh air diffuser located in the top of the unit. Obstructions to airflow, such as books, papers and posters on top of univents, as well as bookcases, tables and desks in front of univent returns, were seen in a number of classrooms. To function as designed, univents and univent returns must remain free of obstructions. Importantly, these units must be activated and allowed to operate during hours of school occupation.

**Exterior Wall Fresh Air Intakes**

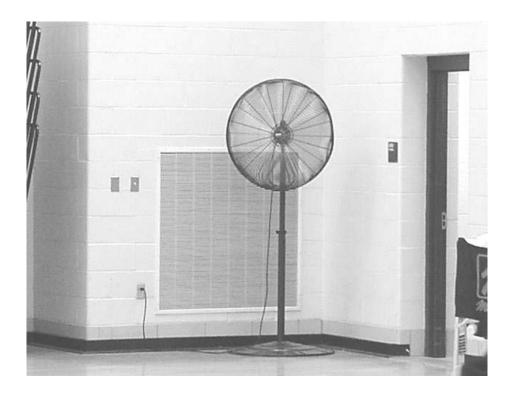
Floor fans were being used in the gymnasium to increase air circulation. The placement of one fan directs air from the wall-mounted exhaust vent (see Picture 3). This placement directs air away from the exhaust vent, therefore decreasing the function of the ventilation system.

Floor Fan in Front of Exhaust Vent in Gymnasium

- 5. Remove all blockages from univents and exhaust vents to facilitate airflow.
- 6. Once both the fresh air supply and exhaust ventilation are functioning, the systems should be balanced by a ventilation engineer.

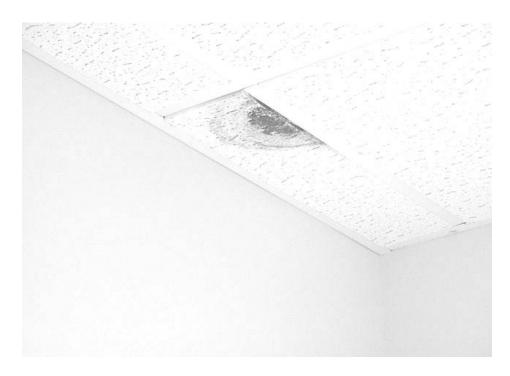
A number of interior areas of the building had signs of water damage. Water damaged ceiling tiles were seen in these areas (see Picture 4), which are evidence of historic roof or plumbing leaks. Water damaged ceiling tiles can serve as a mold growth medium, and should be replaced after a water leak is discovered. The American Conference of Governmental Industrial Hygienists (ACGIH) recommends that porous materials be dried with fans and heating within 24 hours of becoming wet (ACGIH, 1989). If these materials are not dried within this time frame, mold growth may occur. It appears that these materials were dried within this time frame.

Water Damaged Ceiling Tile

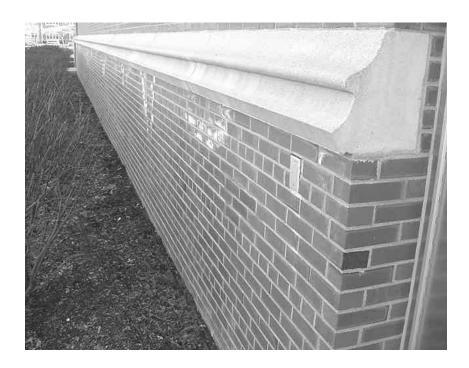
Of note was the condition of the west exterior wall of the 1998 building. The presence of efflorescence (e.g., mineral deposits) on the exterior brickwork was noted beneath seams in cement block (see Picture 5). Efflorescence is a characteristic sign of water damage to brick and mortar, but it is not mold growth. As moisture penetrates and works its way through mortar around brick, water-soluble compounds in bricks and mortar dissolve, creating a solution. As this solution moves to the surface of the brick or mortar, the water evaporates, leaving behind white, powdery mineral deposits. It appears that the seams between cement blocks have deteriorated or were not installed (see Picture 6). Sealing these seams will prevent further damage and water intrusion.

Efflorescence (E.G., Mineral Deposits) on The Exterior Brickwork was Noted Beneath Seams in Cement Block

- 15. Seal utility holes and wall cracks to prevent the egress of dirt, dust and particulate matter between rooms and floors.
- 16. Change filters for air-handling equipment as per the manufacture's instructions or more frequently if needed. Vacuum interior of univents prior to activation to prevent the aerosolization of dirt, dust and particulates. Ensure filters fit flush in their racks with no spaces in between allowing bypass of unfiltered air into the unit. Obtain air filter brackets to prevent air-bypass if multiple filters are installed in one rack.
- 17. Clean chalkboards and chalk trays regularly to prevent the build-up of excessive chalk dust.
- 18. Examine the feasibility of re-pointing the seams of cement blocks on exterior wall of the 1998 building.

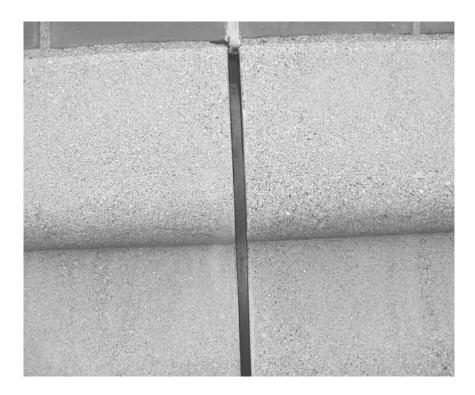
The Seams between Cement Blocks

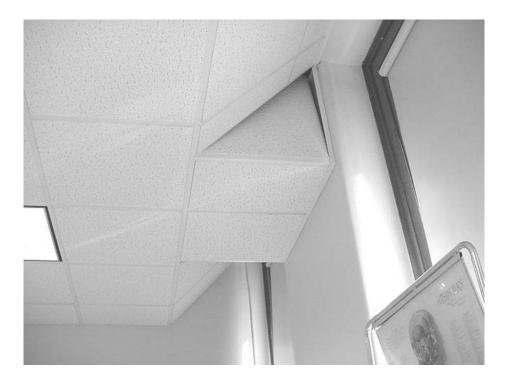
A number of areas throughout the building demonstrated conditions that can result in the aerosolization of materials associated with irritant symptoms into the school environment. Classrooms in the 1915 building had a suspended ceiling installed during renovations. In order to not block windows, bays were built into the ceiling tile system. These bays have triangle-shaped tiles installed *vertically* (see Picture 7) in the sides of each bay to provide a continuous ceiling system. This configuration can lead to the triangular ceiling tiles falling into the ceiling plenum. A number of classrooms have triangular ceiling tiles that are ajar. Ceiling tiles, particularly those above univents, were found leaning into the ceiling plenum, which allows for air expelled from the univent to enter the space between the original and suspended ceilings (see Figure 2). Air forced into the ceiling plenum then pressurizes this space, which can then force air through spaces in the suspended ceiling. Through this pathway, particles in the air stream produced by the univent and that exist above the suspended ceiling can be directed towards the classroom interior. Dust, dirt and other particles can be irritating to the eyes, nose and throat.

Triangle-Shaped Tiles Installed Vertically into Ceiling System

- 9. Repackage material in Picture 12 to an airtight container.
- 10. Examine options for fixing vertical, triangular ceiling tiles in place.

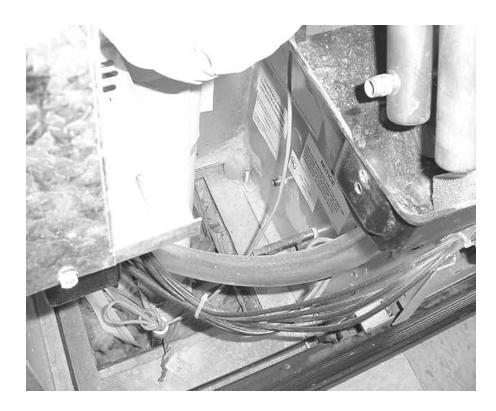
Holes in the floor and spaces around pipes were noted within all univent cabinet interiors surveyed (see Picture 8 and 9). Open pipes and spaces around pipes can serve as pathways for dust, dirt, odors and other pollutants to move from the floor/wall cavities into the cabinet of the univent. Once inside the univent cabinet, these pollutants can then be drawn into the univent airflow and expelled into the classroom.

Holes in the Floor and Spaces around Pipes Were Noted Within All Univent Cabinets

- 7. Render airtight all open pipes and spaces around pipes in univent cabinets.
- 8. Seal holes in univent cabinet walls in contact with airflow to prevent draw of air into post-filter airstream.

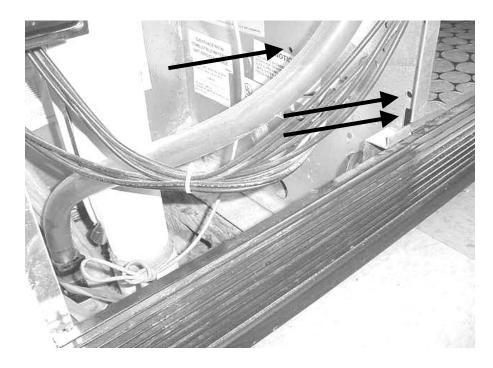
**Holes in Cabinet Wall Post Filter (See Arrows)**

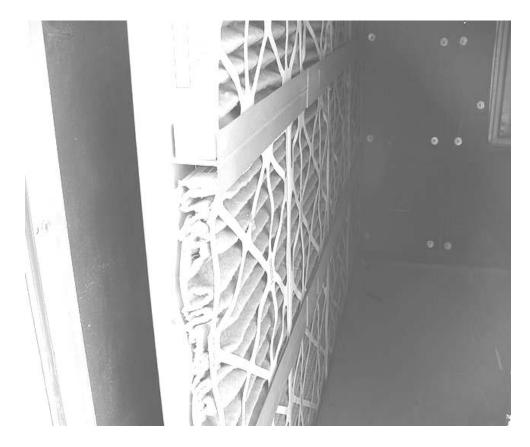
Each univent is also outfitted with a filter. Filters were either undersized or did not fit properly into racks, which results in unfiltered return air being redistributed into the classroom during univent operation. Frames of filters in rooftop AHUs were cut in order to fit inside the cabinet (see Picture 10). Filters that are cut in this manner degrade the ability of the filters to function as designed. This can result in dust, dirt and other debris being distributed by the ventilation system.

Filters Cut To Fit inside Cabinet

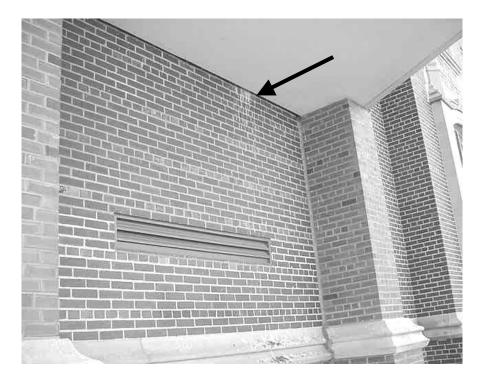
Bird wastes were observed beneath a space between the elevated walkway and its junction with the 1915 building (see Picture 11). The space at this junction allows for birds to roost inside the building envelope in this area. Bird wastes in a building raise three concerns: 1) diseases that may be caused by exposure to bird wastes, 2) the need for clean up of bird waste and 3) appropriate disinfection.

Certain molds are associated with bird wastes and are of concern for immune compromised individuals. Other diseases of the respiratory tract may also result from chronic exposure to bird wastes. Exposure to bird wastes are thought to be associated with the development of hypersensitivity pneumonitis in some individuals. Psittacosis (bird fancier's disease) and histoplasmosis are other conditions closely associated with exposure to bird wastes in either the occupational or bird raising setting. While immune compromised individuals have an increased risk of health impacts following exposure to the materials in bird wastes, these impacts may also occur in healthy individuals exposed to these materials.

Bird Nests Underneath Elevated Walkway, Note Univent Fresh Air Intake below Bird Waste

- Remove birds' nests from the walkway and seal with wire mesh or other appropriate materials. Implement the corrective actions recommended concerning remediation of bird wastes.

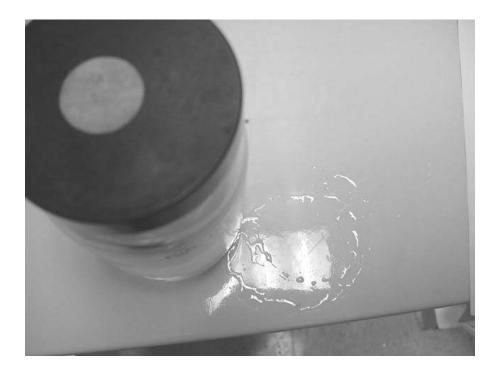
Chemicals were stored in a storeroom on the third floor of the 1998 building. Of note was the condition of a jar of sodium metal found stored in the flameproof cabinet. A

ring of fluid was noted beneath this bottle, which indicates that the liquid inside the container is escaping (see Picture 12). Sodium metal is water reactive (NFPA, 1991) and is an extreme fire hazard. This material must be stored in a non-water liquid to prevent moist air from contacting the surface of this material. The conditions of the container can lead to the eventual drying of the storage liquid and exposure of sodium to the air, which is unacceptable for this material. It is highly recommended that a thorough inventory of chemicals in the science department be done to assess chemical storage and disposal in an appropriate manner consistent with Massachusetts hazardous waste laws.

Sodium Metal With Liquid Leaking from Container
